NASA TM-88007

DC-10 EC-DEG AIRPLANE CRASH IN MALAGA ON SEPTEMBER 13, 1982

Translation of "Accidente del avion DC-10 EC-DEG en Malaga el 13 de Septiembre de 1982," IN: IAA/Ingenieria Aeronautica y Astronautica, January, 1986, Spain, pp. 24-31 (A86-31011) (ISSN 0020-1006)

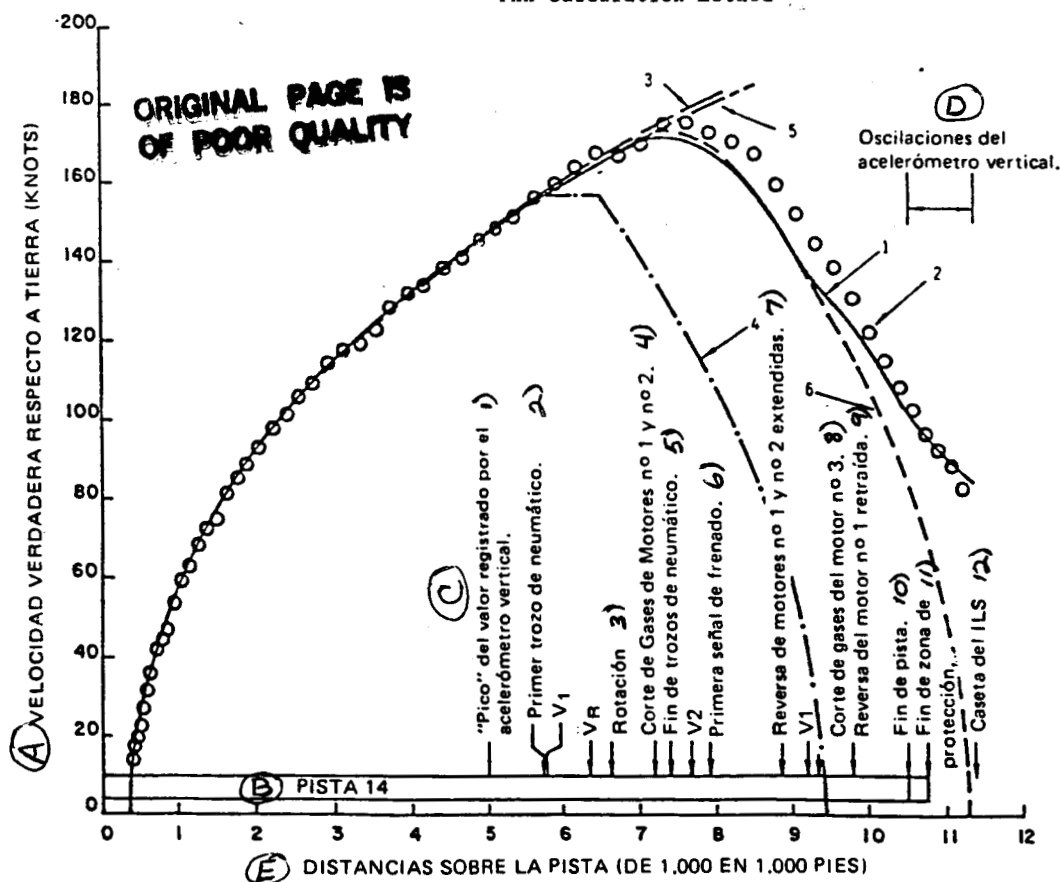
FIG. 1 - ABORTED TAKE-OFF SPEEDS RELATIVE TO DISTANCES

The study performed on the information contained in the flight data recorder has provided the data reflected in figures 1 and 2.

According to the distance/speed curve (fig. 1), the point where the aircraft stopped using the three engines' maximum reverse thrust approximately coincides with the ILS booth's position (fig. 2). Therefore it may be assumed that if the aborted take-off maneuver had been carried out without problems, the aircraft would have stopped approximately in the location of the booth, or it would have crashed against it at well below the 95 Km. actual impact speed.
